Damages of epoxy anti-rust coating on marine structures observed under existence of sea urchins and its protection

Ichiro Katsuyama Seiji Kobayashi Japan NUS Co., Ltd.

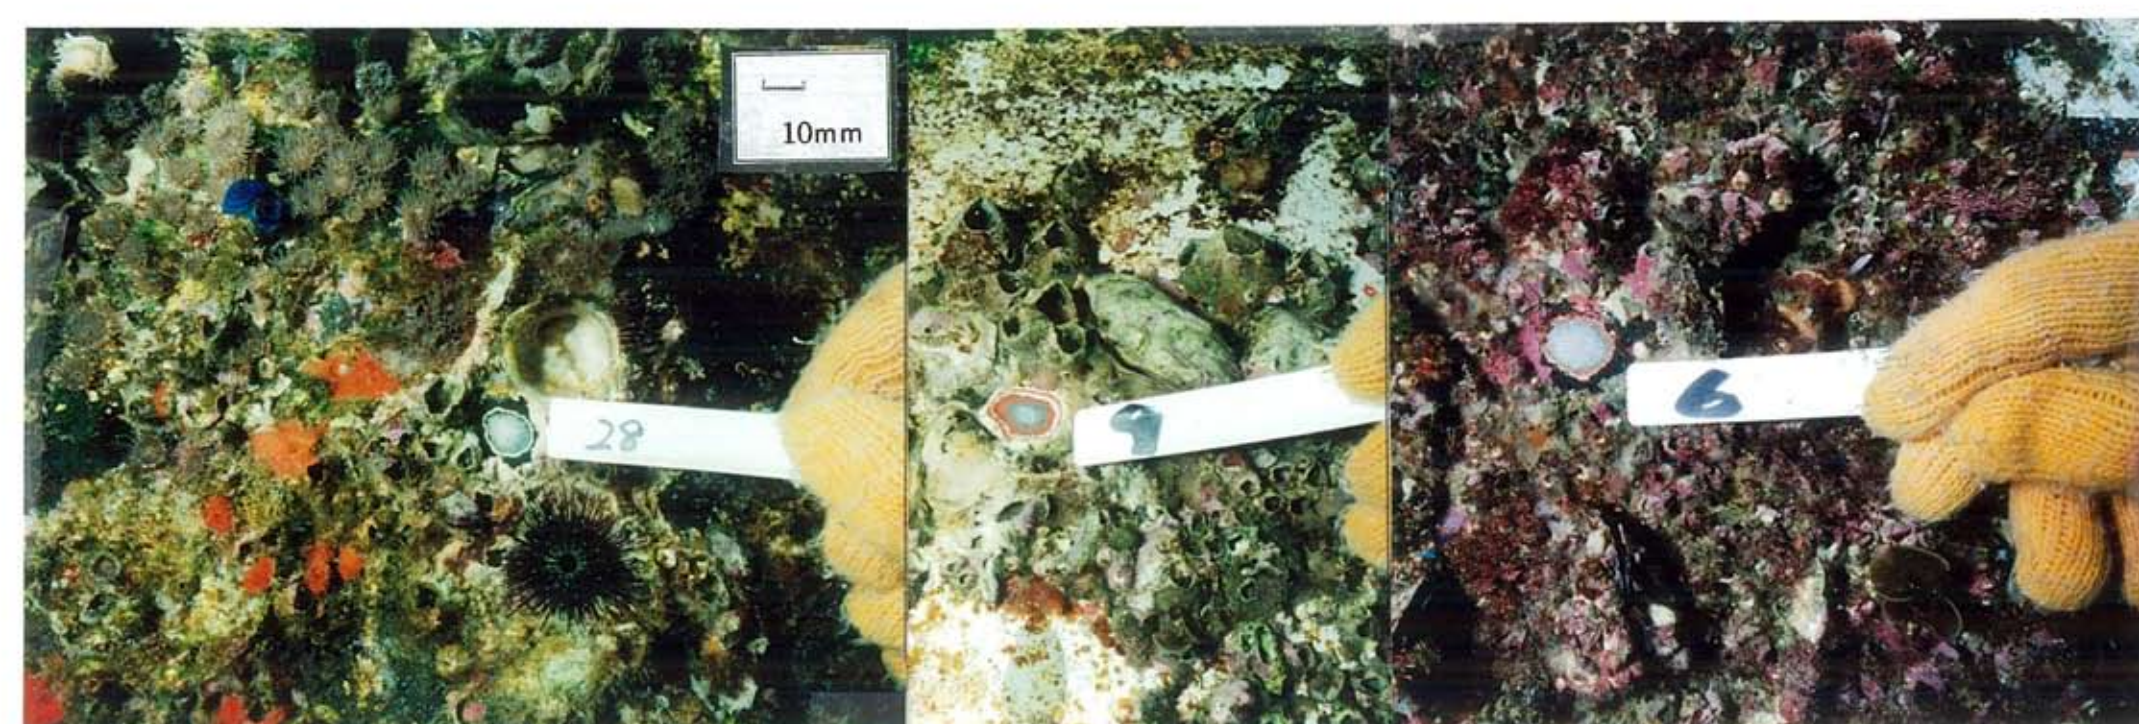
Damage of coating at the place sea urchin (*Echinostrephus molaris*) was found.

Examples of tar epoxy coating (left and right) and epoxy coating (center). Damage shown on the right was observed within 72 hours after sea urchins arrived.

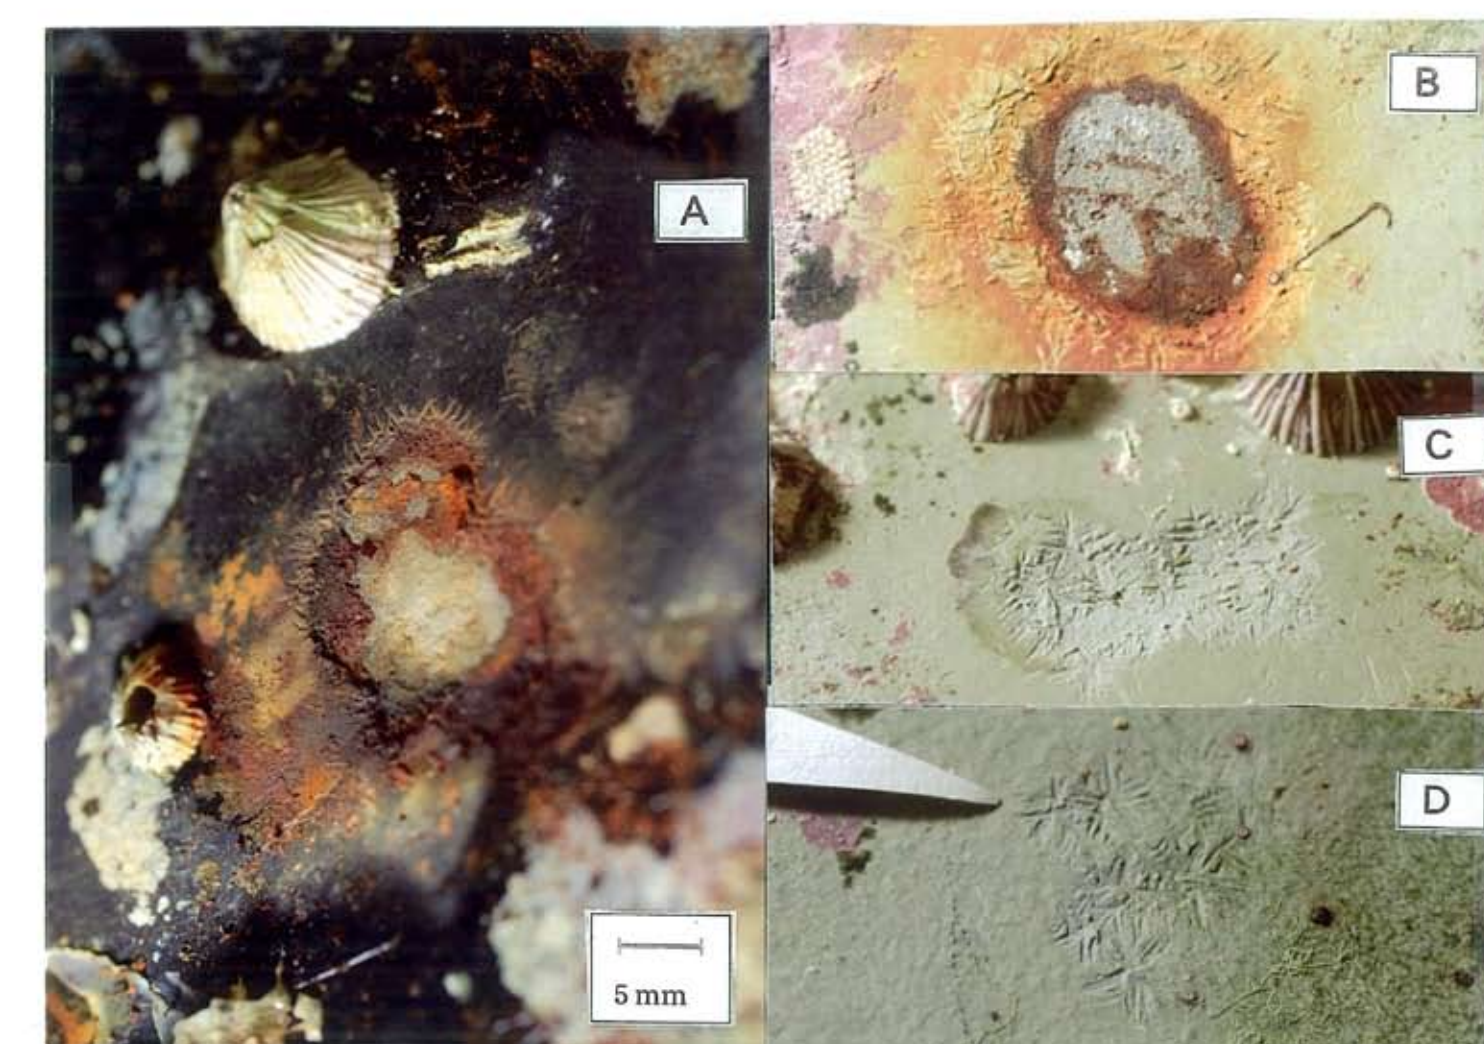
Damage on the coating of the test plate with the sea urchin *E. molaris*.

A: Tar epoxy coating, B: Epoxy coating, C: Epoxy glass flake coating (I), D: Epoxy glass flake coating (II)

- High frequency of coating damage was observed at points where *E. molaris* ('tawasi-uni') were found.
- Their hard teeth may have damaged the surface coating.
- Epoxy-glass-flake paint effectively protected surface coating but this paint was expensive.
- Sea urchins could not damage the coating layer when the MVH was about 40.

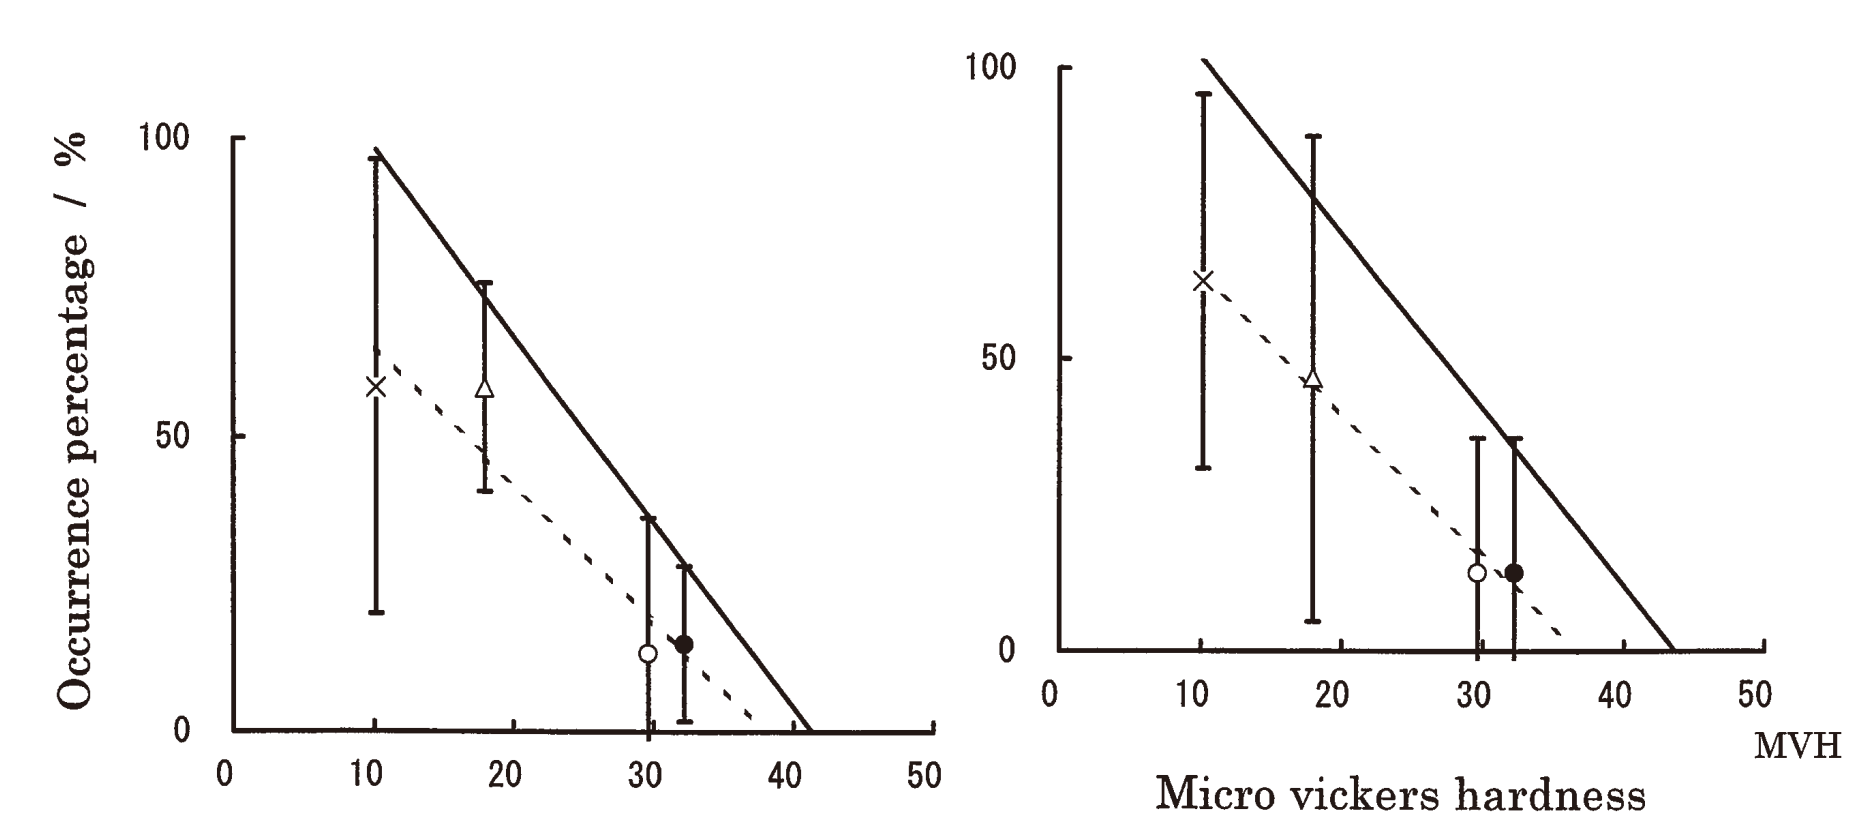
Relationship between damage on coating of the test plate with sea urchin (*E. molaris*) and micro vickers hardness of coating materials.

Left graph shows values after one month and the right shows those after three months from the start of the test. Occurrence (in percent) : numbers of sea urchins that produced damage / numbers of sea urchins observed. × : Tar epoxy coating, △ : Epoxy coating, ○ : Epoxy glass flake coating (I), ● : Epoxy glass flake coating (II).

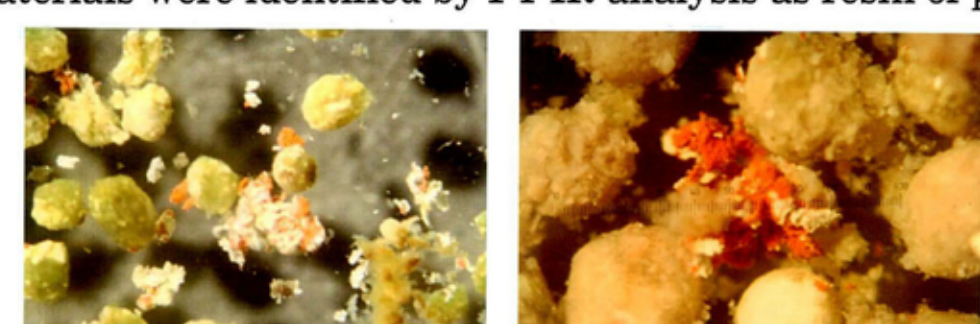
Rusty red and grayish materials, which seem to be pieces of the coating, were observed in the digestive canals of sea urchins (*E. molaris*).

These materials were identified by FT-IR analysis as resin of paint.
