Application of Antibacterial Ability of Metals for Bacterial Control
“A Viable Strategy to Control Bacterial Attachment
and Microbiologically Influenced Corrosion”

Yasuyuki MIYANO */Akita University*
Yoshihiro SATO */Osaka city University*
Yasushi KIKUCHI */Osaka University*

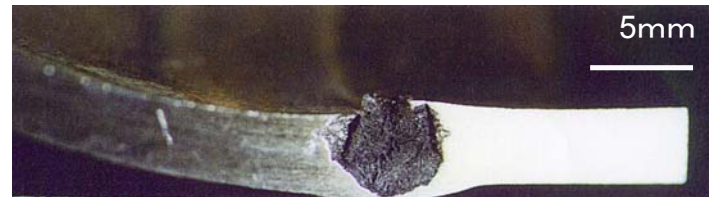
***Stainless steel welds
attacked by MIC***

***Water stream changes over the bead and stagnant around toe.
That is the reason why.....***

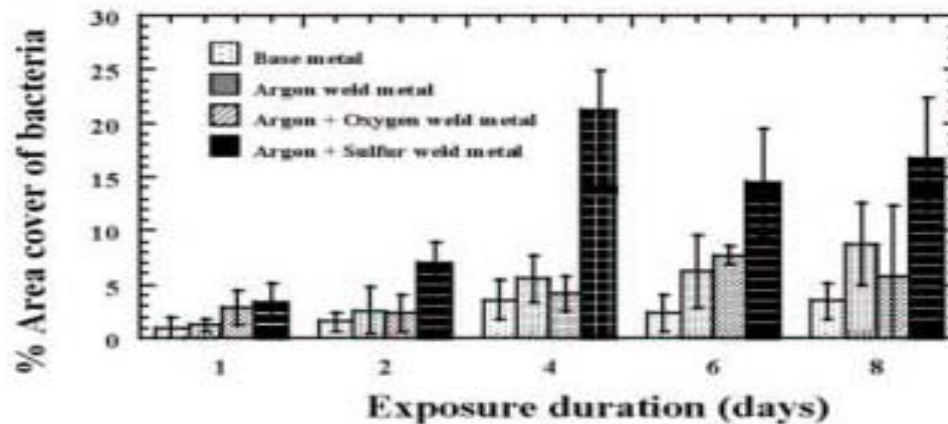
Lab. test : 8 days exposure study using Sulfur rich SS

- Test specimen : Base metal(304L) and welds (S enriched)
- Test solution : *Pseudomonas* sp. culture medium

Sulfur enriched SS welds showed a possibility as a proffered site for bacterial attachment.

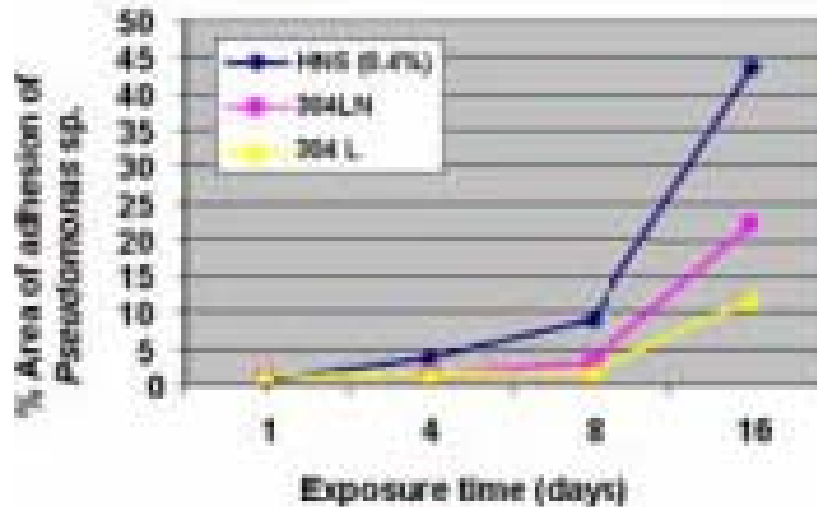
Lab. test : 16 days exposure study using HNS

- High nitrogen containing stainless steel (more than 0.4 weight percent)
- Test solution : *Pseudomonas* sp. culture medium

High nitrogen containing SS (HNS) showed a possibility as a preferred substratum for bacterial attachment.

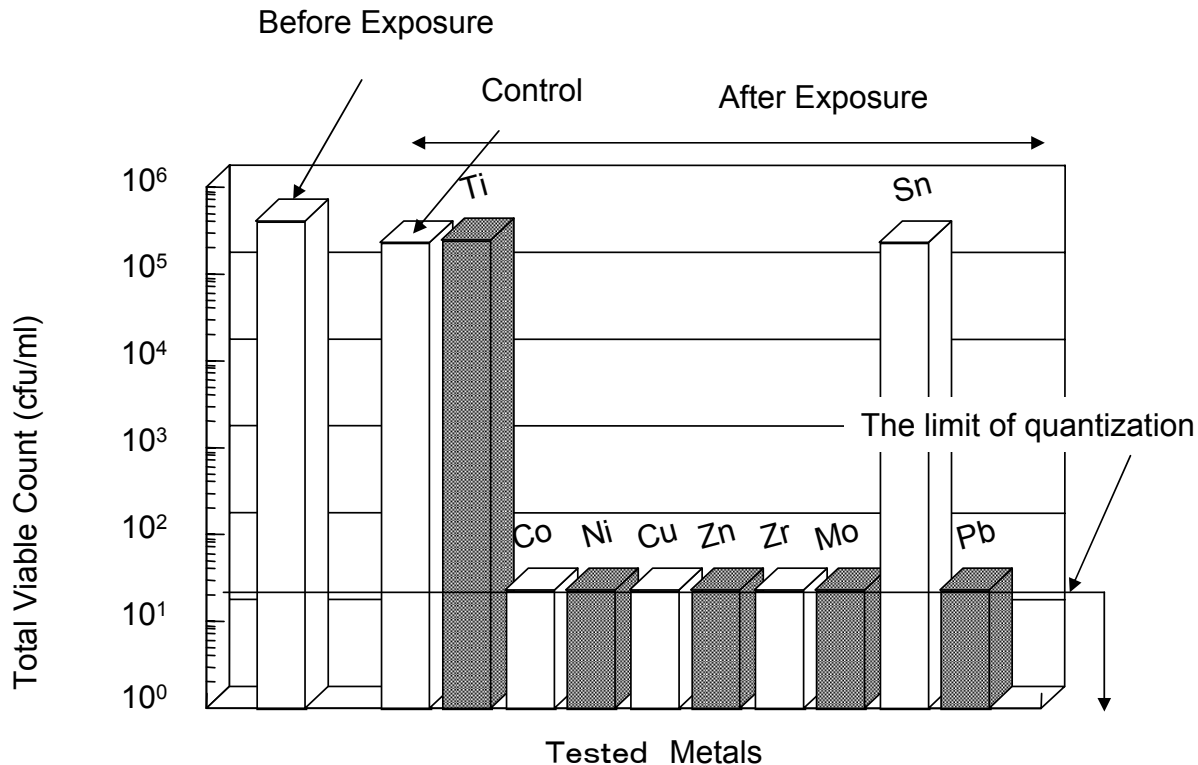
Results: Some pure metals against *Staphylococcus aureus*

Some pure metals showed obvious antibacterial ability by reducing the colony forming units.

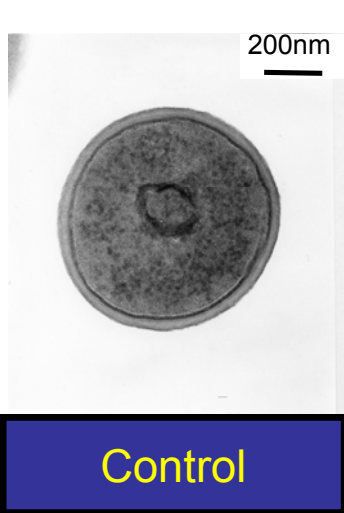
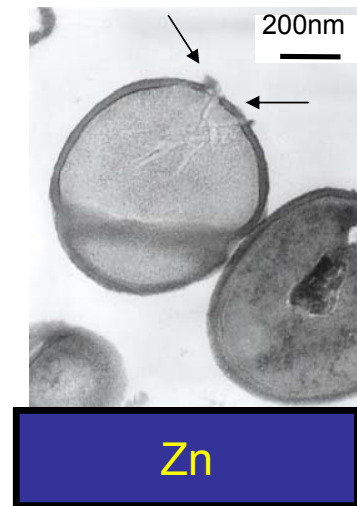
Results : Cell damage observed by TEM after exposure

Negative

Positive

Significant damage was detected in some pure metals.

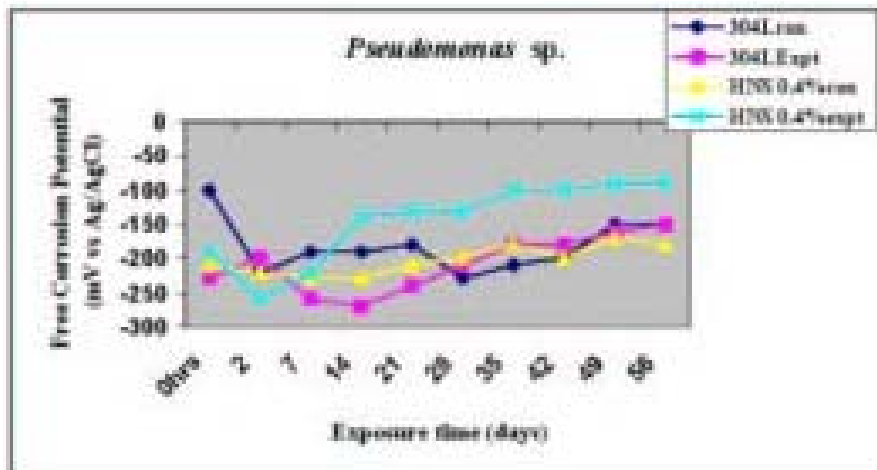
Free corrosion potential to evaluate a susceptibility of HNS was monitored in *Pseudomonas* sp. culture liquid.

High nitrogen containing stainless steel showed more positive free corrosion potential

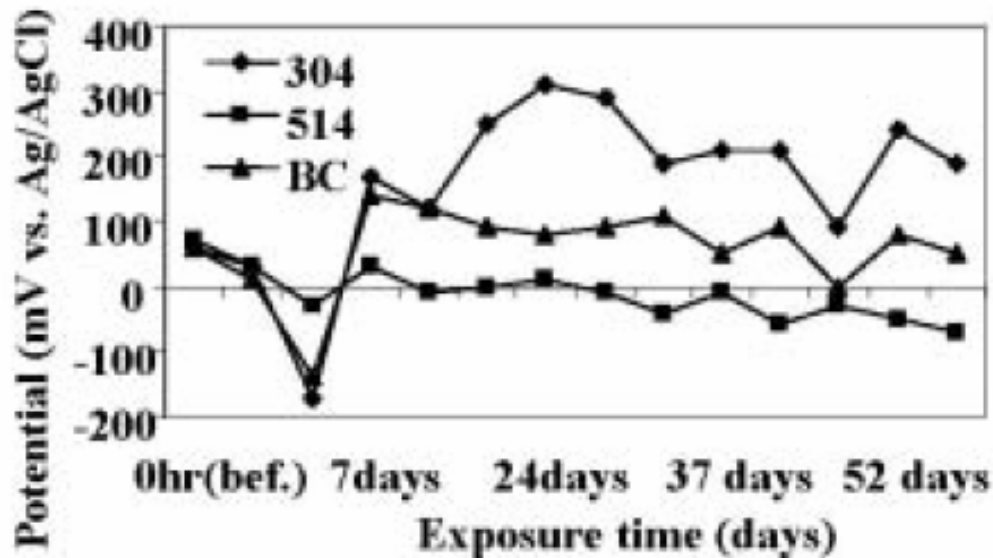
60 days exposure test to *Pseudomonas* sp. cultivation liquid

Corrosion probability was monitored in the laboratory using electrochemical technique
