Damages of epoxy anti-rust coating on marine structures observed under existence of sea urchins and its protection

Ichiro Katsuyama Seiji Kobayashi Japan NUS Co., Ltd.

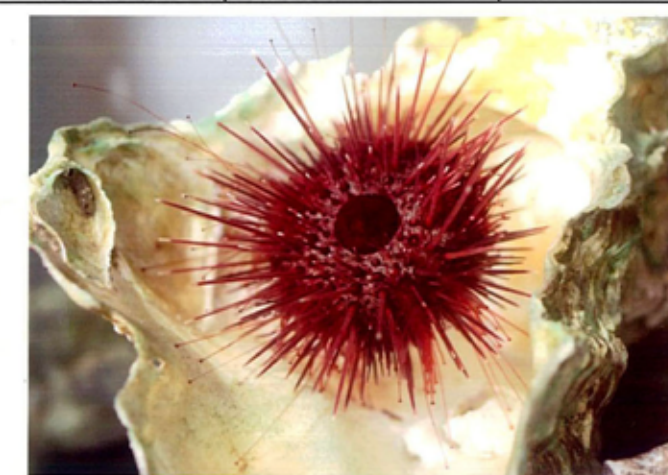
Echinostrephus molaris 'tawasi-uni'

E. molaris 'tawasi-uni' that are frequently observed on the coating surface, in most cases, stay in holes dug in rock beds along sea coasts and eat sea weeds that flow into the holes. Since they cannot dig holes on metal structures, it is thought that they crawl on the surface of marine structures, foraging for sea weeds and barnacles. During feeding, their hard teeth may damage the coating. The survey showed that a high frequency of coating damage was observed at points where *E. molaris* 'tawasi-uni' individuals were found.

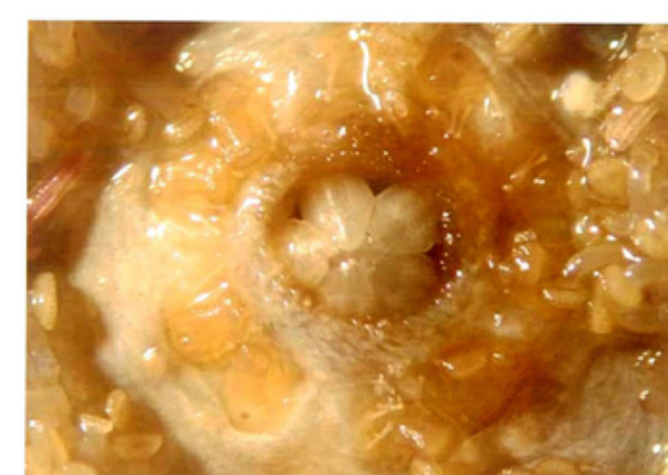
Teeth of *Echinostrephus molaris* 'tawasi-uni'

- High frequency of coating damage was observed at points where *E. molaris* ('tawasi-uni') were found.
- Their hard teeth may have damaged the surface coating.
- Epoxy-glass-flake paint effectively protected surface coating but this paint was expensive.
- Sea urchins could not damage the coating layer when the MVH was about 40.
